**National Property Inspections**  
196 E. 6th St. Suite 401, Sioux Falls, SD 57104

Wednesday, April 10, 2019  
**Inspector**  
Brian Shabino  
(605) 321-9517  
brian.shabino@npiinspect.com

Inspection Date : 4/10/2019 11:30 AM

Property Location : **26360 464TH AVE  
HARTFORD SD 57033**

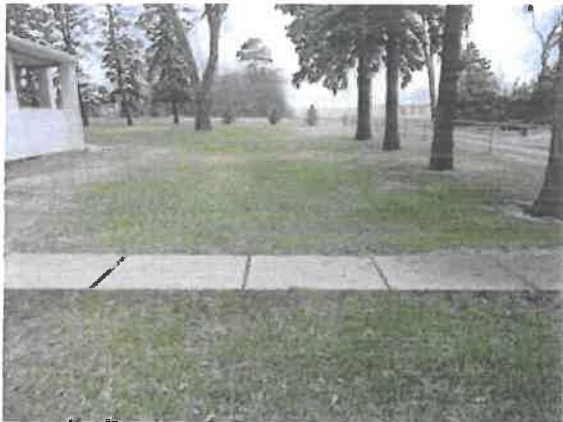
The grading on this property was near level. This condition may allow water to accumulate around the house during rains and has the potential to allow water to enter the dwelling. Monitor condition during rains as improvements in grading/drainage may be needed.

near level

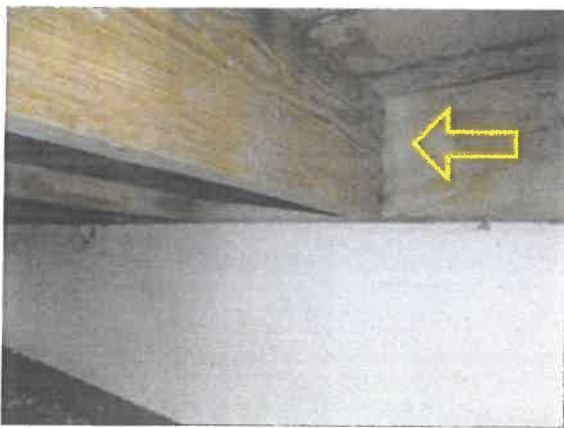
Support joists were missing properly installed mechanical hangers on the ledger board. Joists were nailed on ends of joist to rim joist. Recommend adding joist hangers for better security of decking. Handrail had horizontal balusters and openings greater than 4". Recommend installing vertical baluster no more than 4" apart for safety.

missing joist hangers

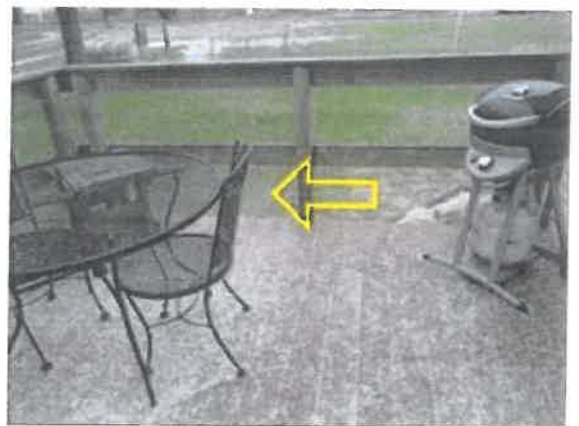
horizontal balusters, open spaces

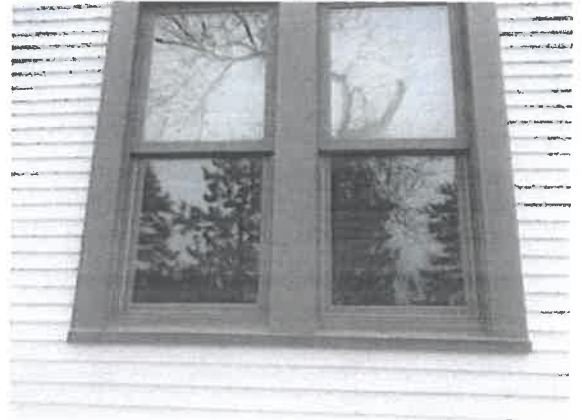
Multiple missing screens. Recommend installing screens to prevent pest intrusion when windows are open.

missing screens

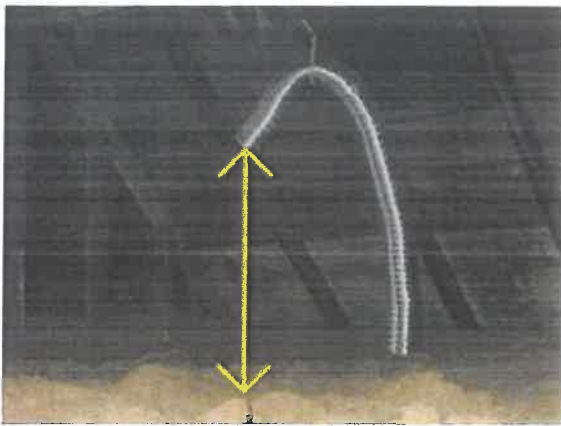
The bathroom exhaust hose was venting into the attic area. The bathroom ceiling is testing as having elevated levels of moisture directly under the vent opening. Recommend further evaluation and installation of the correct type of bathroom exhaust vent to prevent any possible moisture intrusion and degradation of the sheathing / roofing system.

moisture testing in bathroom ceiling

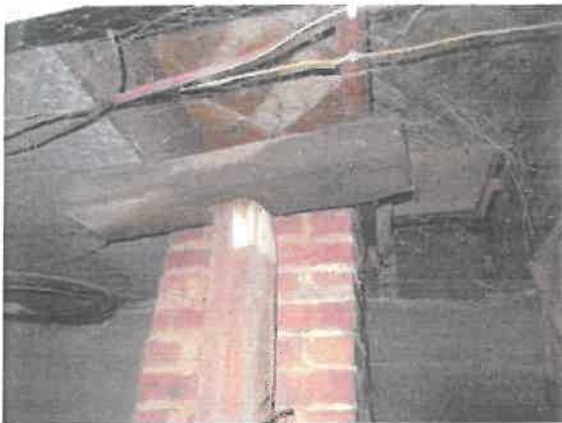
Post and beams supporting area around the steps and chimney are not properly secured.  
Recommend further evaluation/repair by qualified contractor(s).

secure post and beam

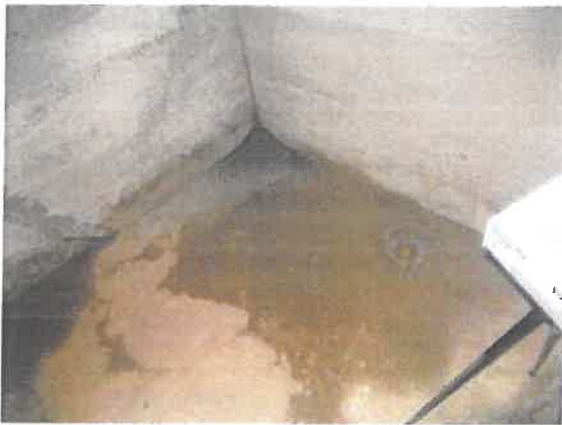
Stains visible on the interior surfaces of the concrete floor slab appear to be the result of active moisture intrusion. . Moisture intrusion could damage materials and encourage the growth of microbes such as mold. The source of moisture should be located and corrected to avoid future moisture intrusion. Repairs to grading may be needed to move water further away from foundation.

moisture

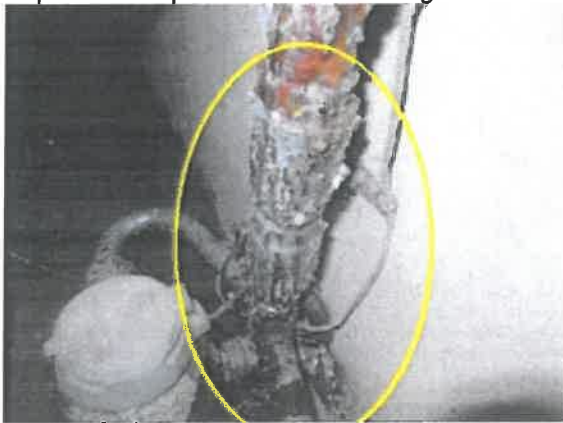
Leaking noted at the main water supply. Recommend further evaluation and repairs by a licensed plumber to prevent further leaking.

leaking on main

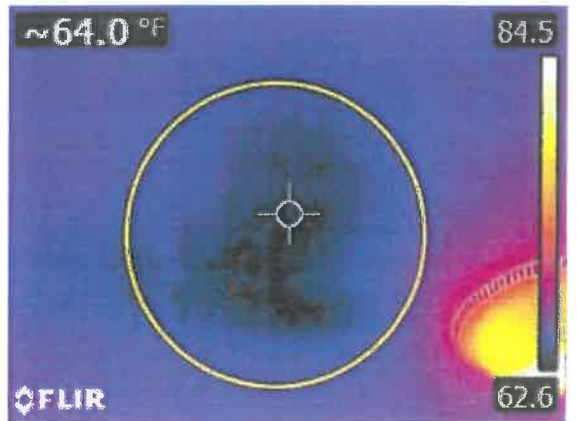
moisture

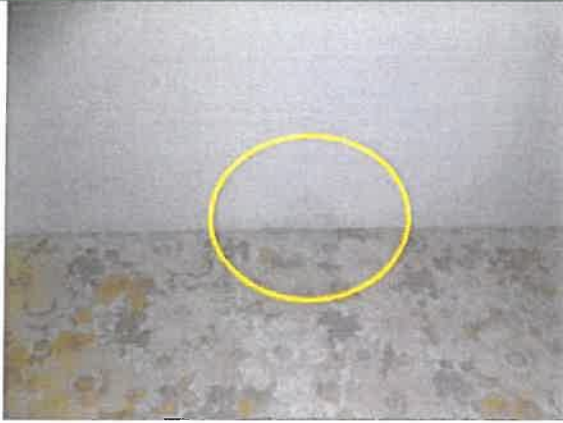
Stain(s) at ceiling tested dry on day of observation. Monitor for moisture related deterioration. "Mold like growth" observed in the NW corner at time of this inspection. Mold identification and testing are beyond the scope of this inspection. Further evaluation/environmental testing should be considered to properly identify further environmental concerns and issues. Corner tested dry on day of inspection.

moisture related stains

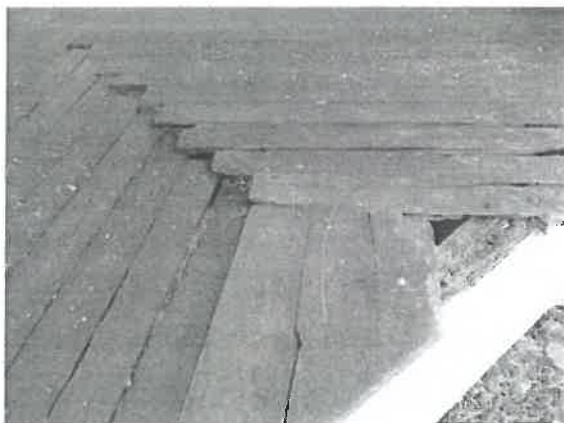
Loose/deteriorated floor board(s) observed. Recommend replacing deteriorated and loose boards to prevent possible tripping/falling hazard.

Deteriorated floor boards

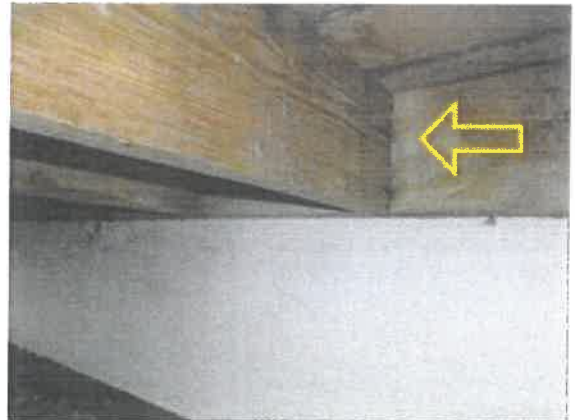
Support joists were missing properly installed mechanical hangers on the ledger board. Joists were nailed on ends of joist to rim joist. Recommend adding joist hangers for better security of decking.  
Handrail had horizontal balusters and openings greater than 4". Recommend installing vertical baluster no more than 4" apart for safety.

missing joist hangers

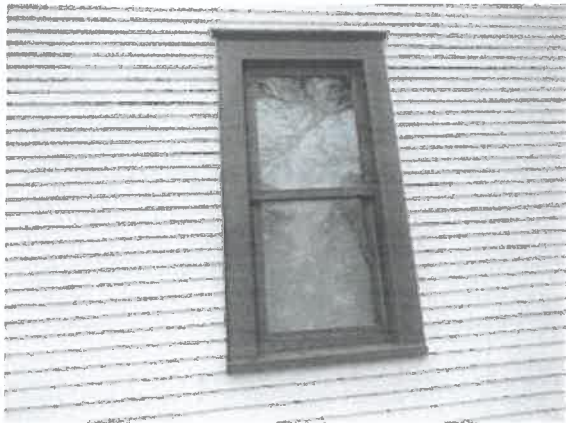
**Multiple missing screens. Recommend installing screens to prevent pest intrusion when windows are open.**

missing screen

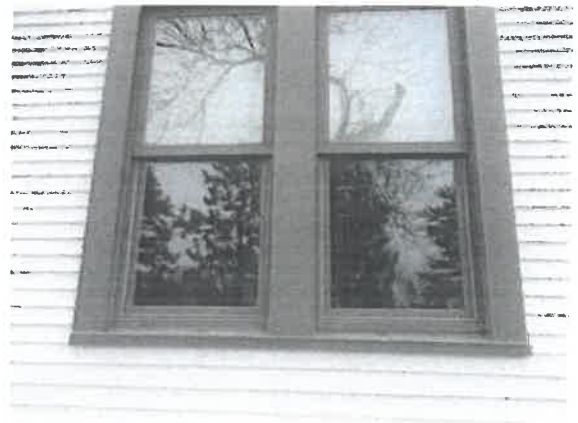
missing screens

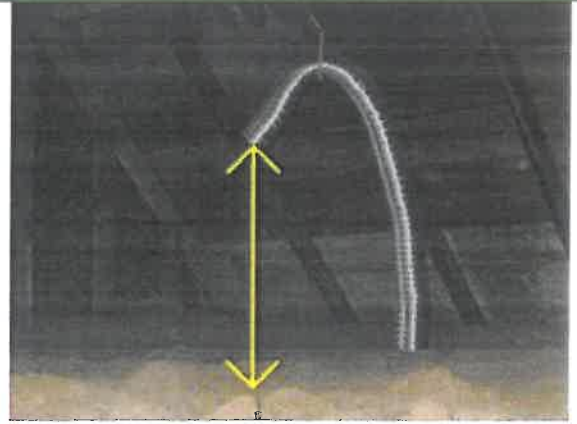
The bathroom exhaust hose was venting into the attic area. The bathroom ceiling is testing as having elevated levels of moisture directly under the vent opening. Recommend further evaluation and installation of the correct type of bathroom exhaust vent to prevent any possible moisture intrusion and degradation of the sheathing / roofing system.

moisture testing in bathroom ceiling

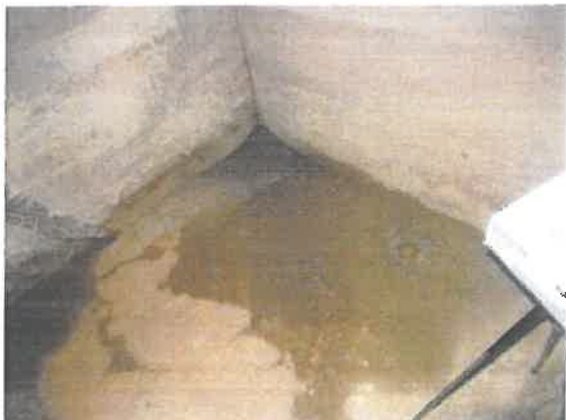
Stains visible on the interior surfaces of the concrete floor slab appear to be the result of active moisture intrusion. Moisture intrusion could damage materials and encourage the growth of microbes such as mold. The source of moisture should be located and corrected to avoid future moisture intrusion. Repairs to grading may be needed to move water further away from foundation.

moisture

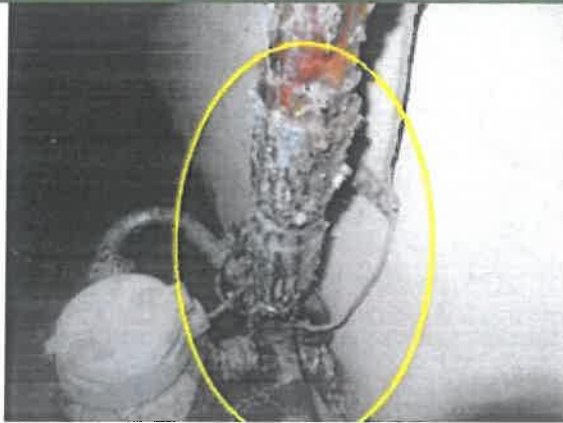
Leaking noted at the main water supply. Recommend further evaluation and repairs by a licensed plumber to prevent further leaking.

leaking on main

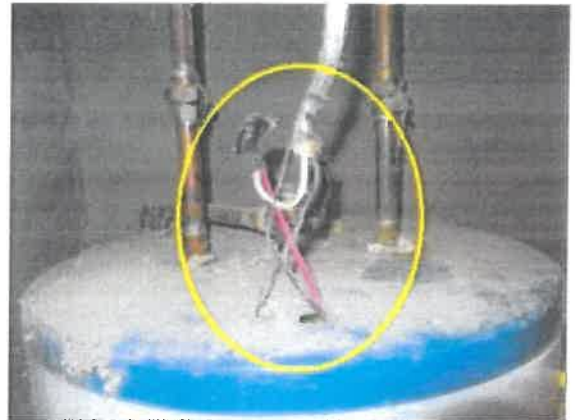
Electrical wiring is connected on the outside of the tank housing. This may lead to possible electrical shocks or issues. Recommend securing wiring inside the water heater housing area as designed for safety.

wiring should be in the water heater housing

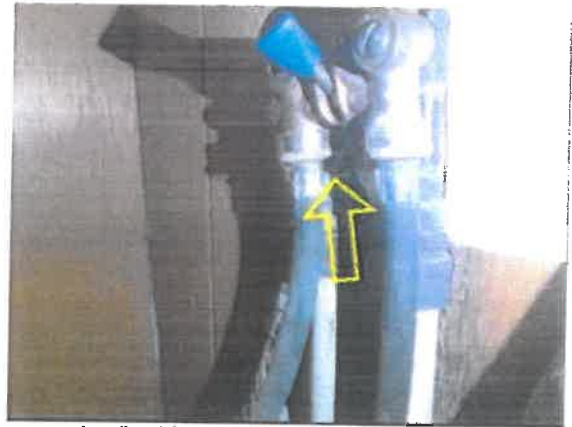
Corrosion and leaking noted at hot water connections. Recommend further evaluation and repairs by a qualified plumber.

corrosion/leaking

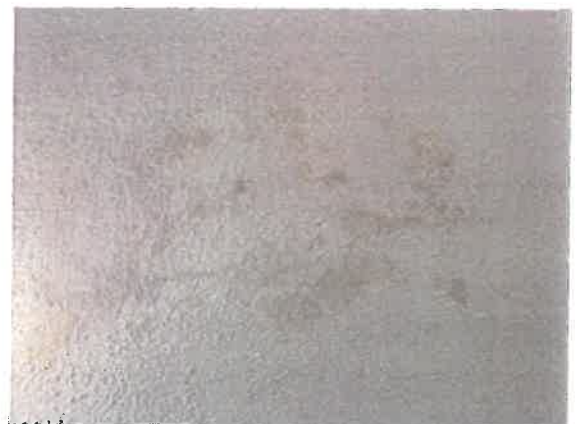
moisture stains

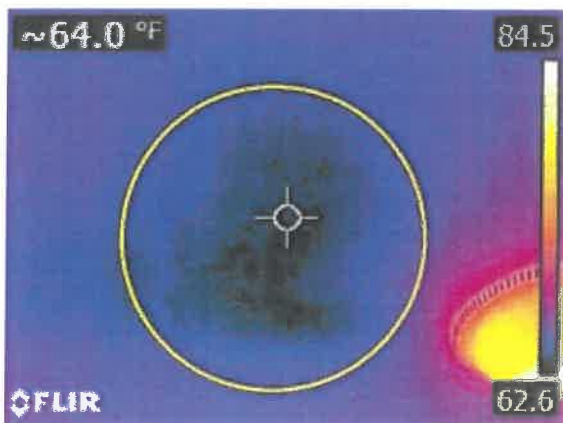
moisture

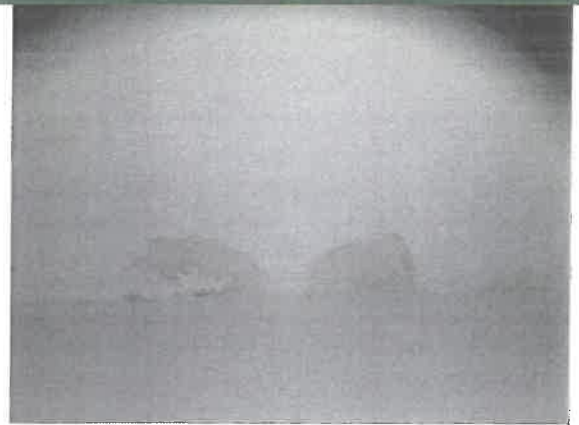
moisture stains

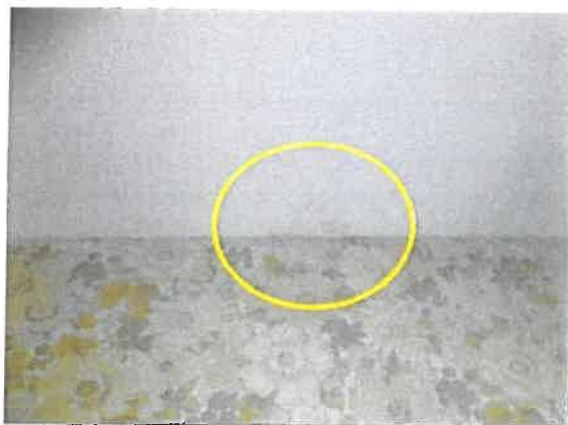
moisture related stains

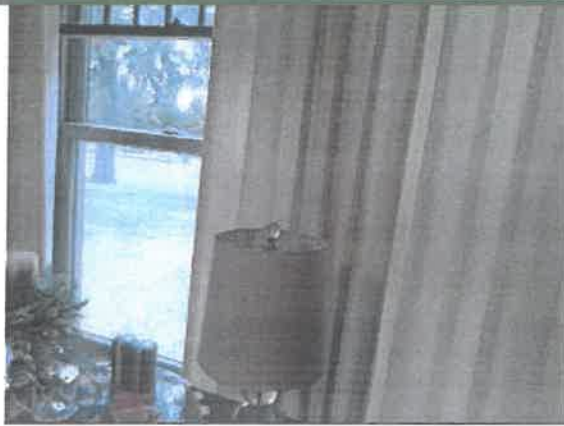
Missing window screen(s). Recommend having all window screens installed before final walk through to verify presence and condition.

missing screens
