**National Property Inspections**  
196 E. 6th St. Suite 401, Sioux Falls, SD 57104

Wednesday, April 10, 2019  
**Inspector**  
Brian Shabino  
(605) 321-9517  
brian.shabino@npiinspect.com

Inspection Date : 4/10/2019 11:30 AM

Property Location : **26360 464TH AVE  
HARTFORD SD 57033**

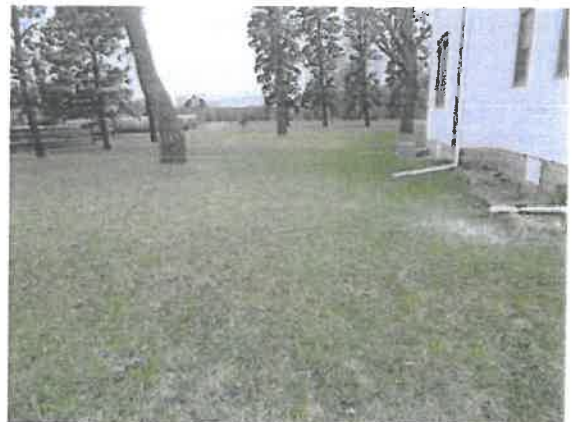
The grading on this property was near level. This condition may allow water to accumulate around the house during rains and has the potential to allow water to enter the dwelling. Monitor condition during rains as improvements in grading/drainage may be needed.

near level

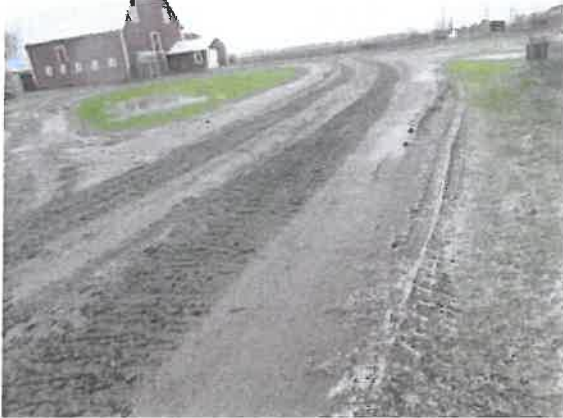
Gravel driveway was muddy and had low spots. Gravel driveways may erode from heavy rains. Consider adding larger size rock and gravel to the driveway to prevent potholes, deterioration and muddy conditions.

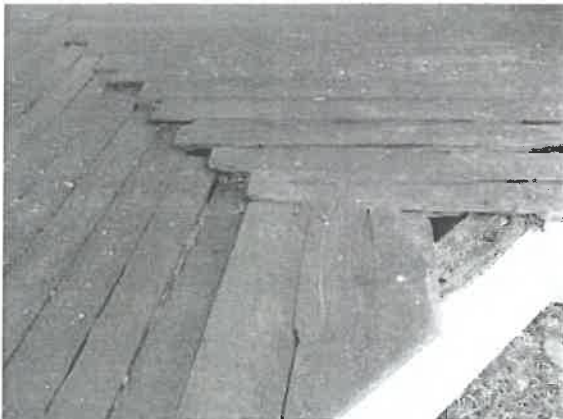
Loose/deteriorated floor board(s) observed. Recommend replacing deteriorated and loose boards to prevent possible tripping/falling hazard.  
No steps installed on porch. Area where steps should be is open with no rail. Recommend installing steps or handrail with balusters to prevent possible falls off the porch.

Deteriorated floor boards

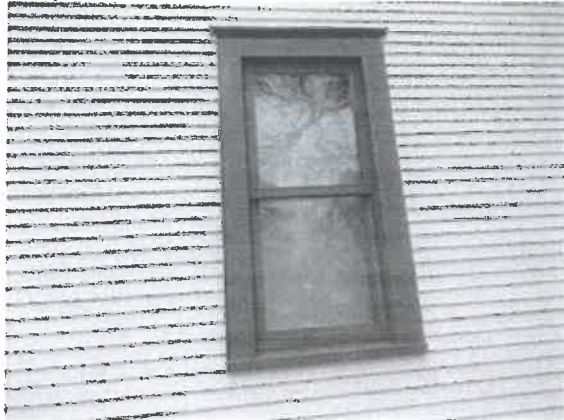
Multiple missing screens. Recommend installing screens to prevent pest intrusion when windows are open.

missing screen

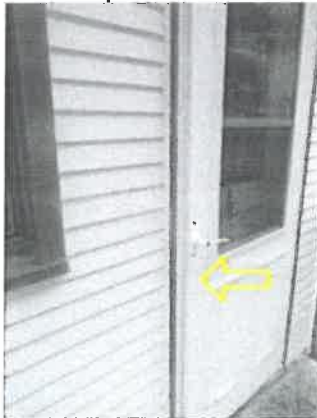
Front storm door sticks on framing and does not properly close. Recommend adjusting to allow door to shut and seal as designed.

sticks on frame

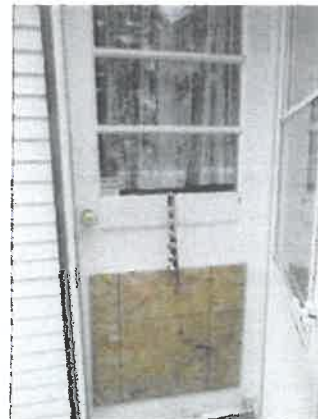
Front wood door has previous repairs completed. Consider replacing door for aesthetics.

previous repairs

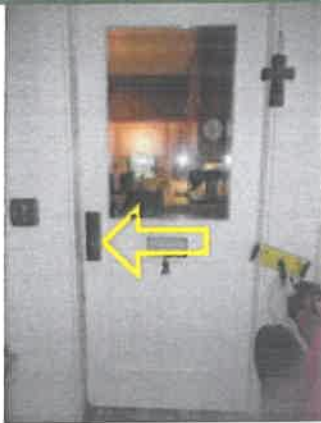
Interior porch door does not latch. Recommend adjusting door and hardware to allow door shut and latch.

does not latch

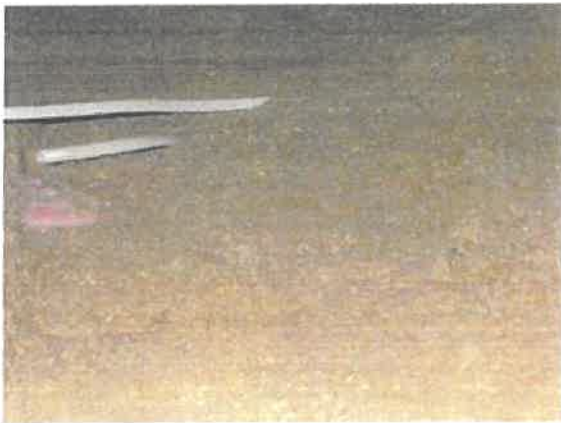
Loose-fill Cellulose insulation present, approximately 7-8 inches deep, estimated R value 24-28  
Current standard for attic insulation is recommended to be R49 in value. You may wish to look at upgrading the insulation level in the near future.

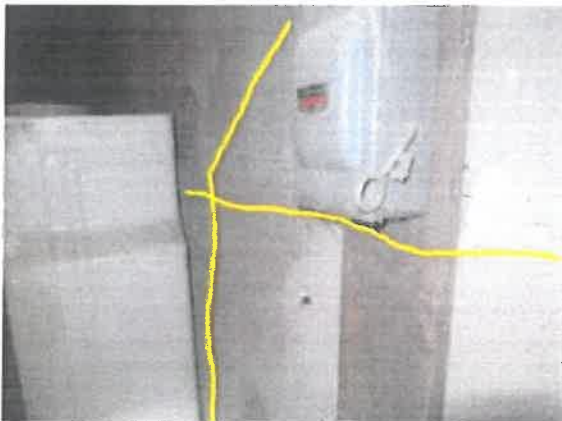
Block foundation was covered with concrete skim coat. Bowing noted on one wall. Monitor conditions and repair if condition worsens. Moisture coming in from pipe opening in the foundation. Recommend discovering the purpose of this pipe and repairing area to prevent further moisture intrusion. Grading along the exterior may need to be addressed to move water further from the foundation to prevent moisture intrusion to the basement.

slight bowing

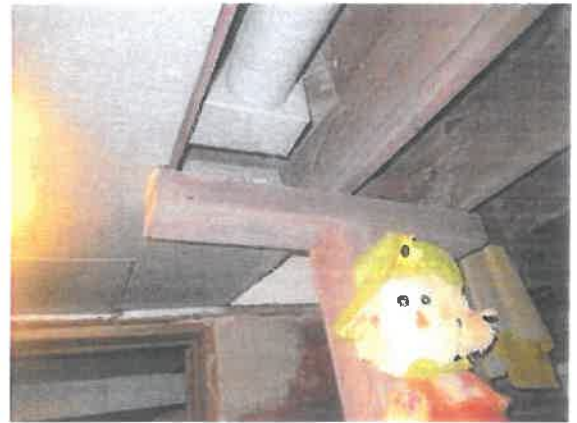
Post and beams supporting area around the steps and chimney are not properly secured.  
Recommend further evaluation/repair by qualified contractor(s).

secure post and beam

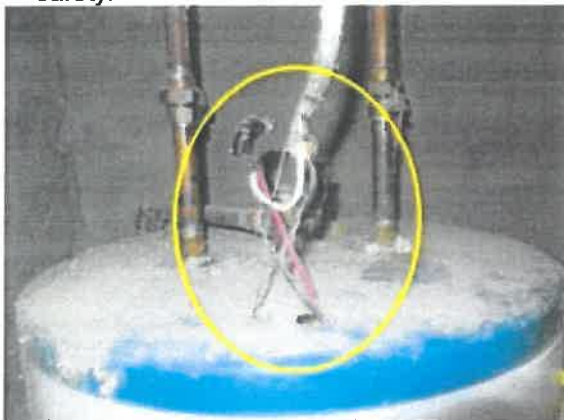
Electrical wiring is connected on the outside of the tank housing. This may lead to possible electrical shocks or issues. Recommend securing wiring inside the water heater housing area as designed for safety.

wiring should be in the water heater housing

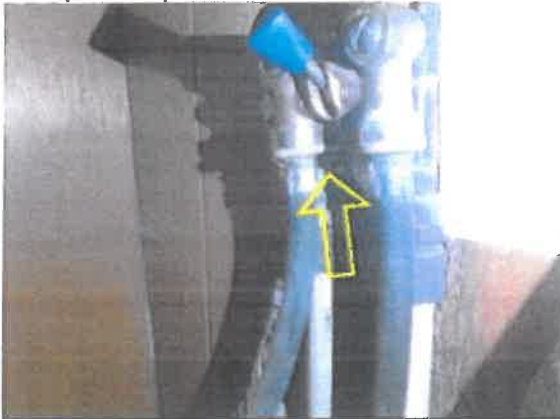
Corrosion and leaking noted at hot water connections. Recommend further evaluation and repairs by a qualified plumber.

corrosion/leaking

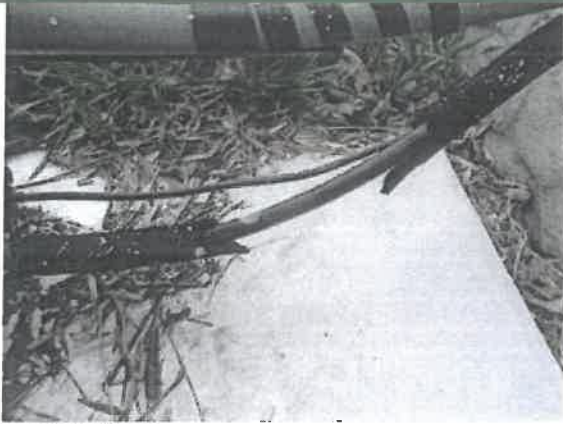
A/C copper suction line missing insulation. Recommend adding new insulation to copper lines for increased energy efficiency.

insulate lines

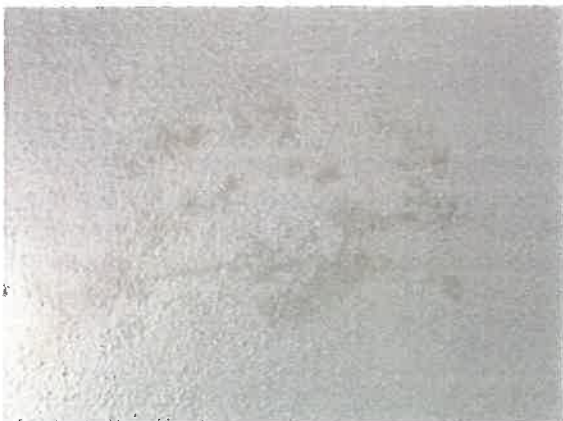
The drain stopper assembly on the tub was missing/broken. Repair as desired.  
Entry door does not latch and seal. Recommend adjustments to allow door to close as designed.  
Stains were observed on the ceiling and tested as having elevated levels of moisture. The bathroom exhaust vent is venting into the attic with the exit directly above this area that is testing as having moisture. Bathroom vent also addressed in the attic ventilation section.  
Recommend further evaluation/repair by qualified contractor(s).

moisture stains

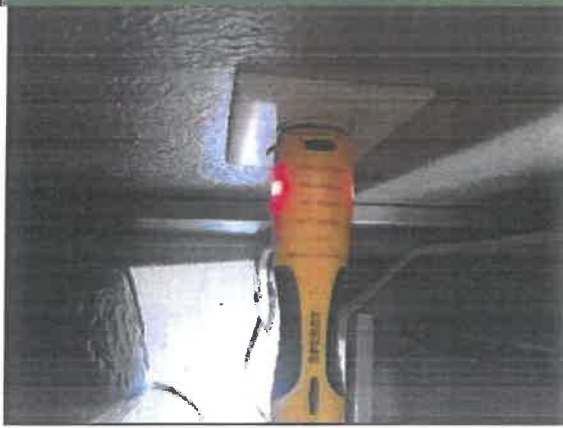
Outlets are a combination of 2 prong ungrounded outlets and 3 prong ungrounded outlets. This is common in homes built before 1962. Recommend further evaluation by a licensed electrician to see what steps can be taken to make the ungrounded outlets safer.

3-prong ungrounded outlets.

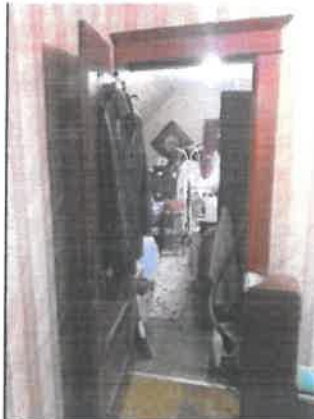
door opens into hallway

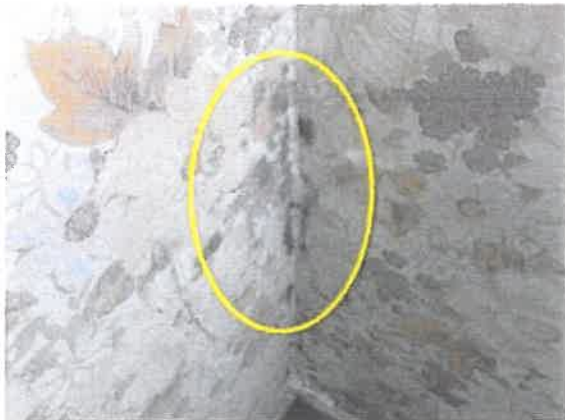
Stain(s) at ceiling tested dry on day of observation. Monitor for moisture related deterioration. "Mold like growth" observed in the NW corner at time of this inspection. Mold identification and testing are beyond the scope of this inspection. Further evaluation/environmental testing should be considered to properly identify further environmental concerns and issues. Corner tested dry on day of inspection.

organic growth

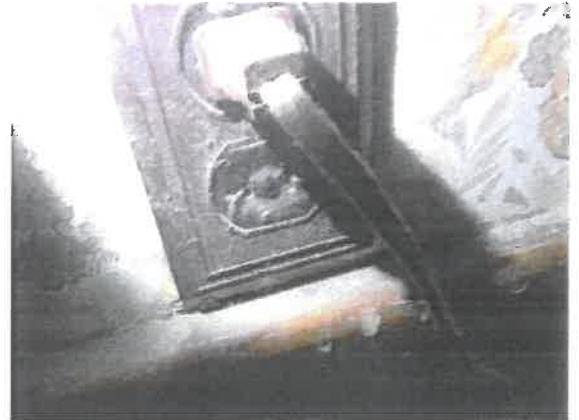
Outlets are 2 prong ungrounded outlets. This is common in homes built before 1962. Recommend further evaluation by a licensed electrician to see what steps can be taken to make the ungrounded outlets safer.

2-prong outlets

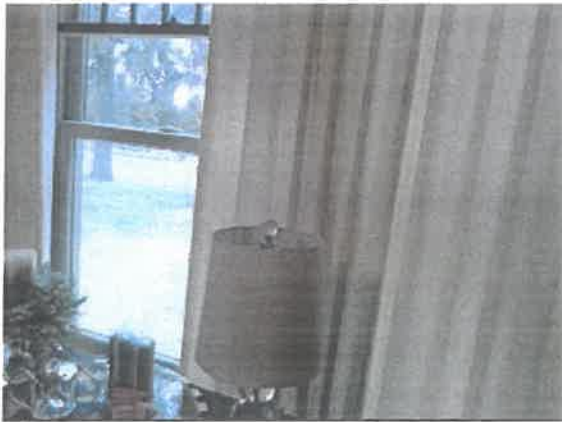
Missing window screen(s). Recommend having all window screens installed before final walk through to verify presence and condition.

missing screens

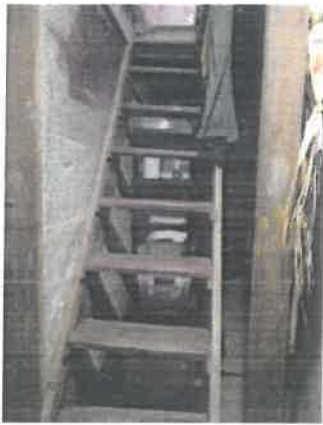
Steps leading to basement have over spaced risers, and no handrail and an open wall. Stairs that have an open wall on one side should have a railing with balusters no more than 4" apart for safety. Recommend further evaluation/repair by qualified contractor(s).

dangerous steps

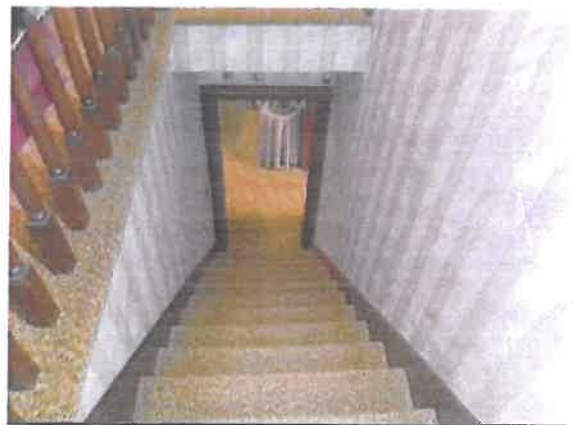
Steps leading upstairs were missing a handrail. Any stairway with four or more risers should have a handrail on at least one side.

no handrail

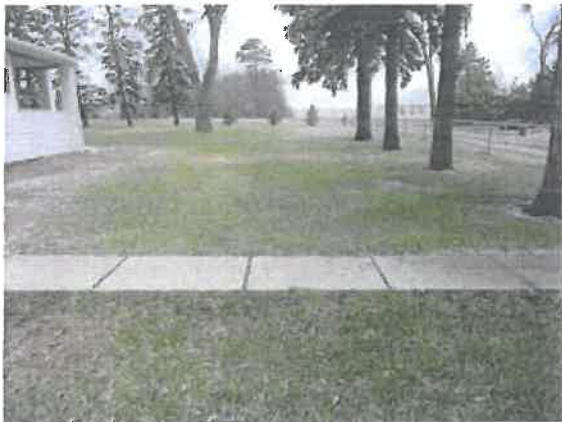
The grading on this property was near level. This condition may allow water to accumulate around the house during rains and has the potential to allow water to enter the dwelling. Monitor condition during rains as improvements in grading/drainage may be needed.

near level

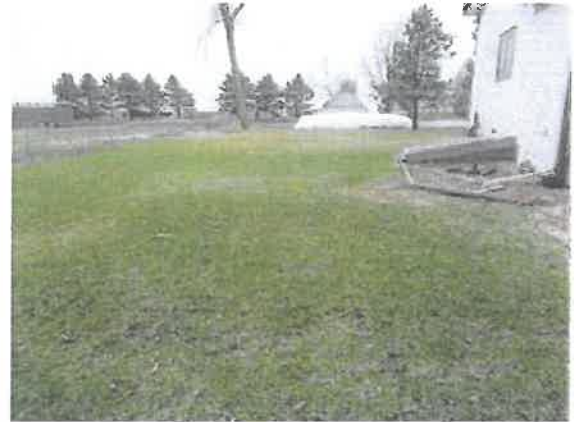
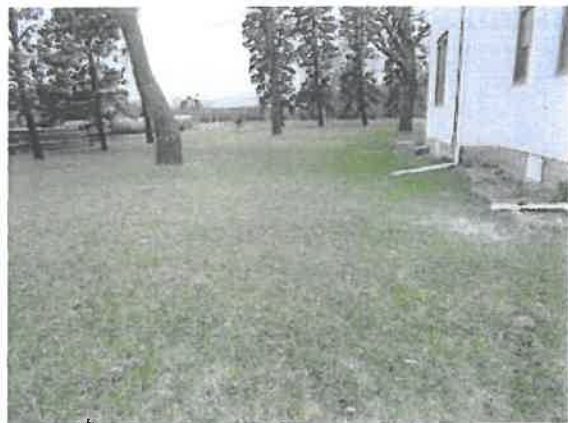
near level

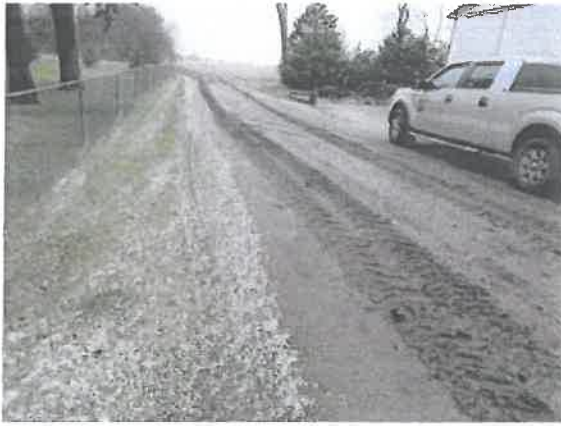
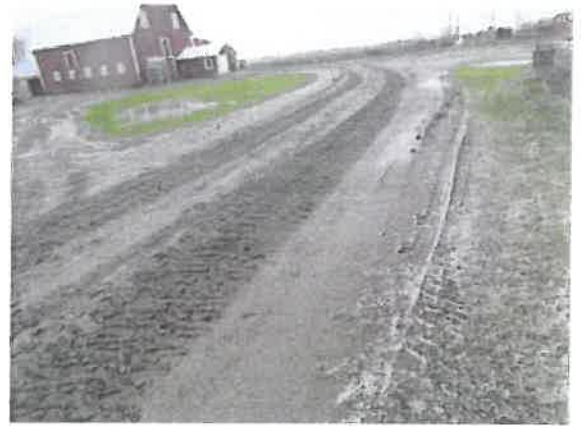
Gravel driveway was muddy and had low spots. Gravel driveways may erode from heavy rains. Consider adding larger size rock and gravel to the driveway to prevent potholes, deterioration and muddy conditions.

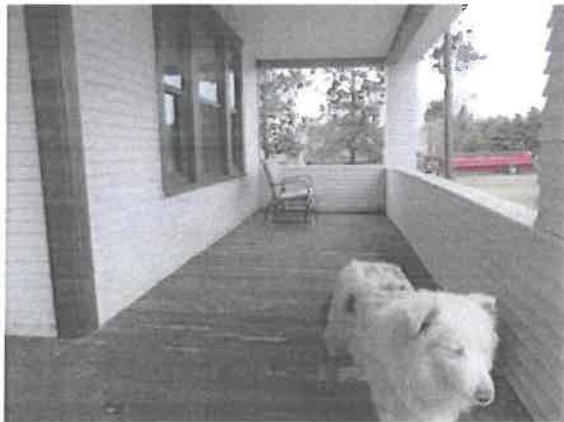
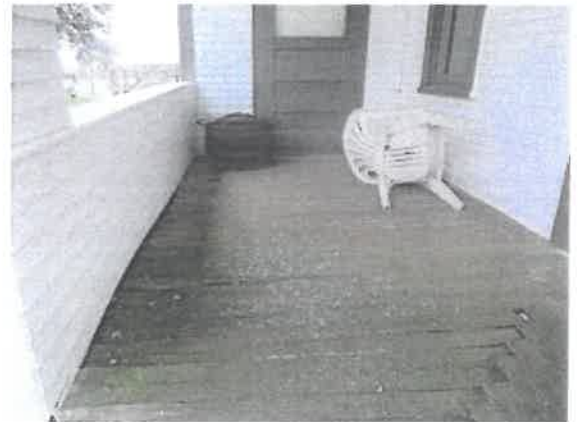
Loose/deteriorated floor board(s) observed. Recommend replacing deteriorated and loose boards to prevent possible tripping/falling hazard.

Deteriorated floor boards

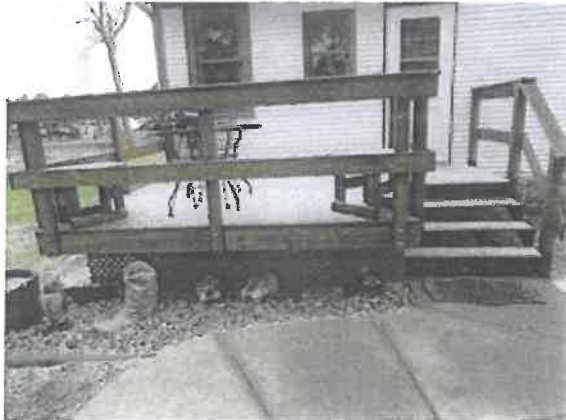
Support joists were missing properly installed mechanical hangers on the ledger board. Joists were nailed on ends of joist to rim joist. Recommend adding joist hangers for better security of decking.  
Handrail had horizontal balusters and openings greater than 4". Recommend installing vertical baluster no more than 4" apart for safety.

missing joist hangers

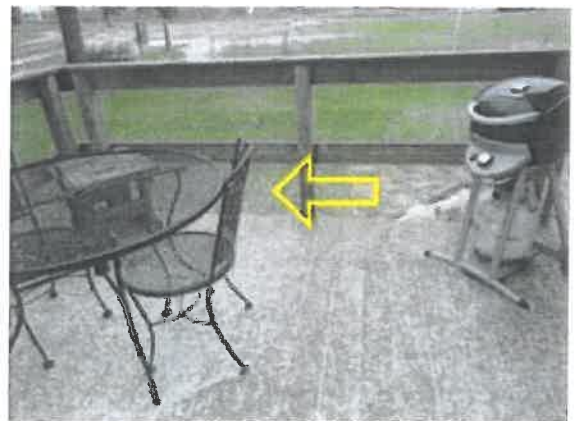
horizontal balusters, open spaces

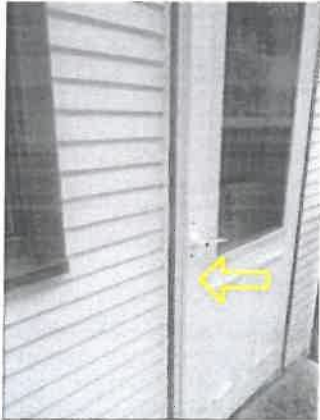
Front storm door sticks on framing and does not properly close. Recommend adjusting to allow door to shut and seal as designed.  
 Front wood door has previous repairs completed. Consider replacing door for aesthetics.  
 Interior porch door does not latch. Recommend adjusting door and hardware to allow door shut and latch.  
 West porch door is sealed shut and not operational.

sticks on frame

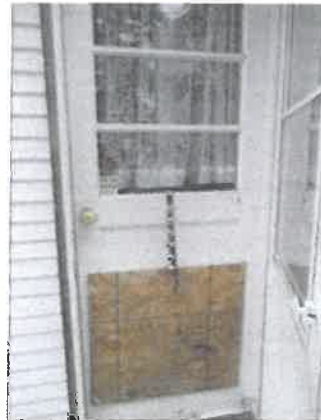
previous repairs

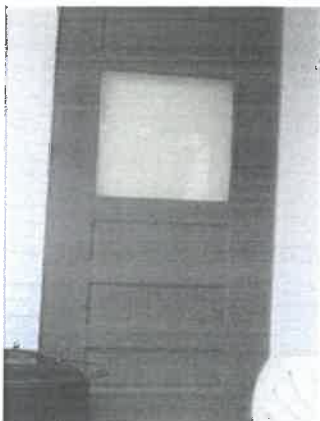
porch door sealed, not in use

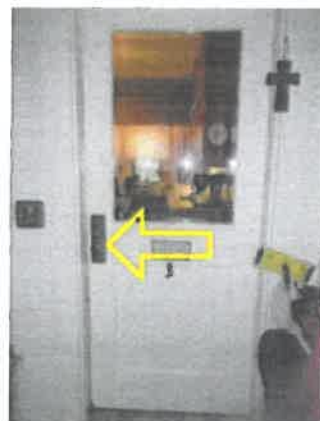
does not latch

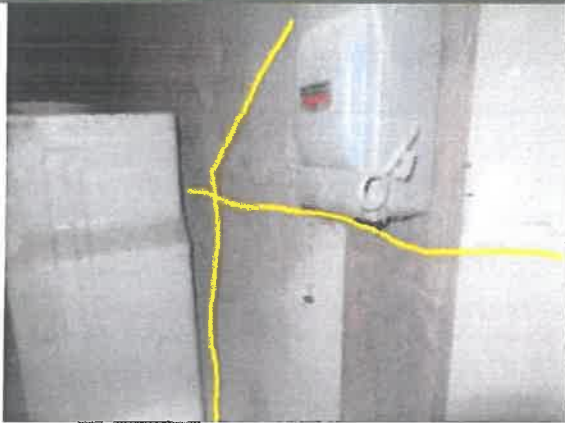
Block foundation was covered with concrete skim coat. Bowing noted on one wall. Monitor conditions and repair if condition worsens. Moisture coming in from pipe opening in the foundation. Recommend discovering the purpose of this pipe and repairing area to prevent further moisture intrusion. Grading along the exterior may need to be addressed to move water further from the foundation to prevent moisture intrusion to the basement.

slight bowing

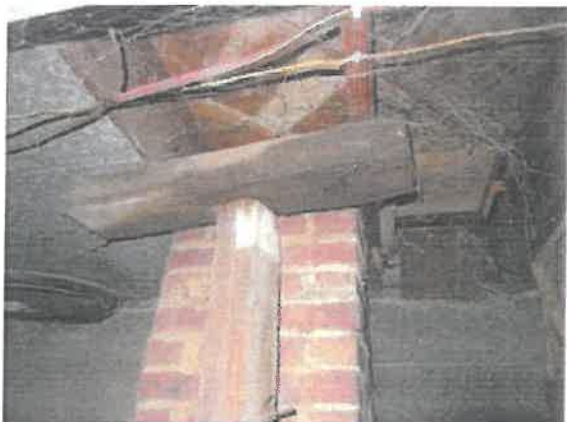
Post and beams supporting area around the steps and chimney are not properly secured. Recommend further evaluation/repair by qualified contractor(s).

secure post and beam

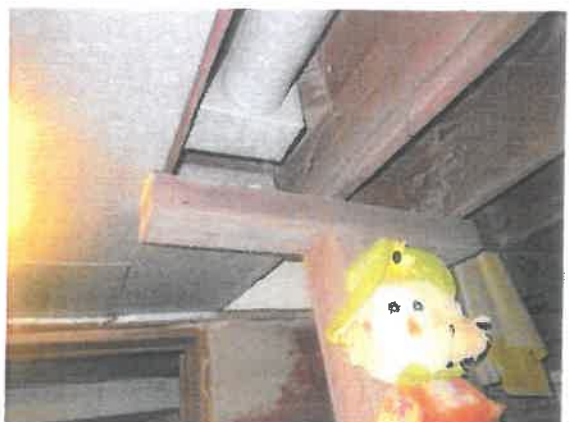
secure post and beam

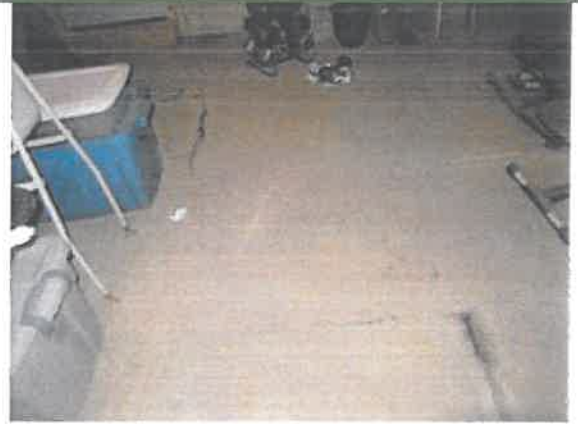
Stains visible on the interior surfaces of the concrete floor slab appear to be the result of active moisture intrusion. Moisture intrusion could damage materials and encourage the growth of microbes such as mold. The source of moisture should be located and corrected to avoid future moisture intrusion. Repairs to grading may be needed to move water further away from foundation.

moisture

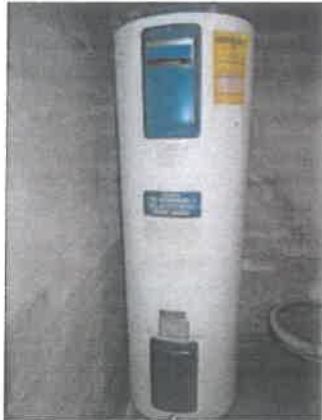
Electrical wiring is connected on the outside of the tank housing. This may lead to possible electrical shocks or issues. Recommend securing wiring inside the water heater housing area as designed for safety.

wiring should be in the water heater housing

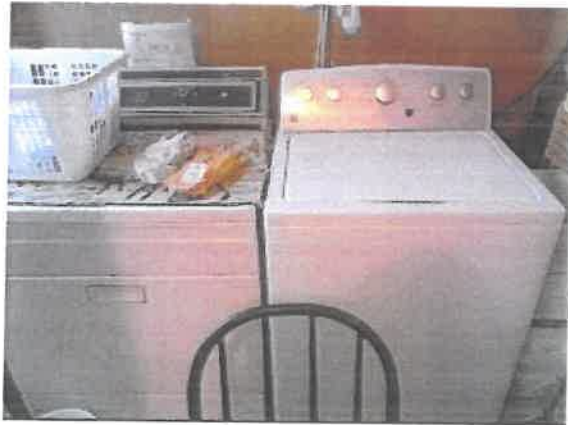
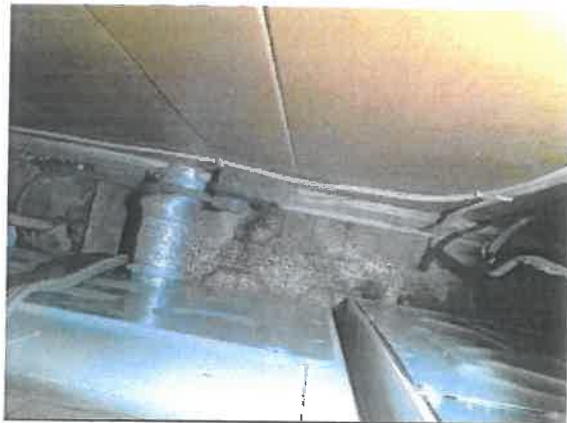
Corrosion and leaking noted at hot water connections. Recommend further evaluation and repairs by a qualified plumber.

corrosion/leaking

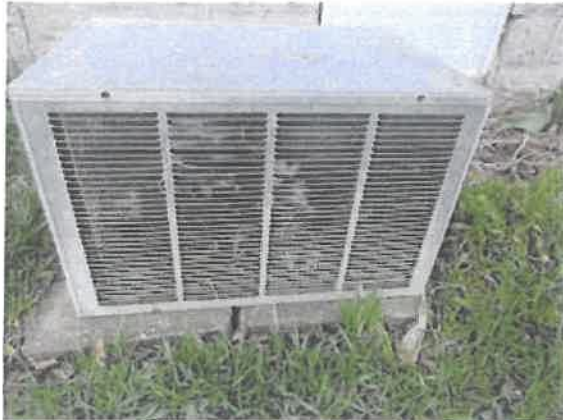
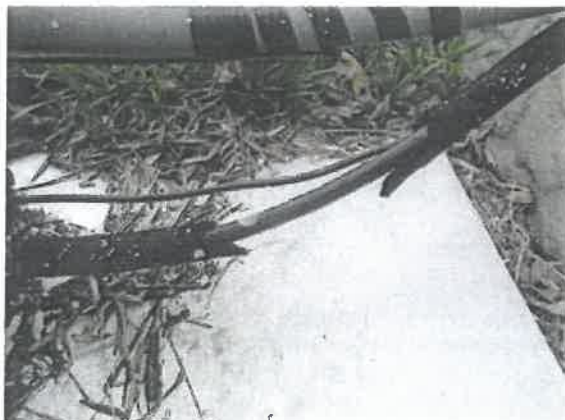
A/C copper suction line missing insulation. Recommend adding new insulation to copper lines for increased energy efficiency.

insulate lines

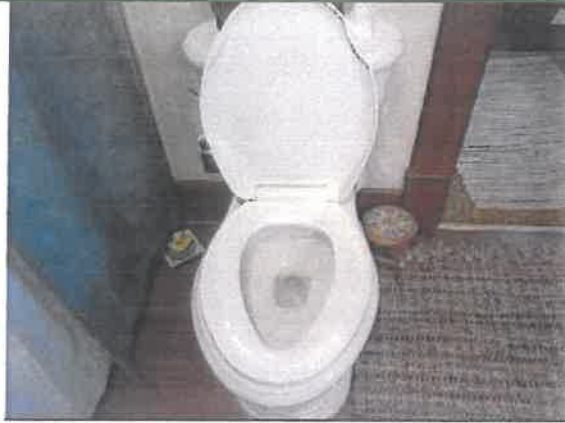
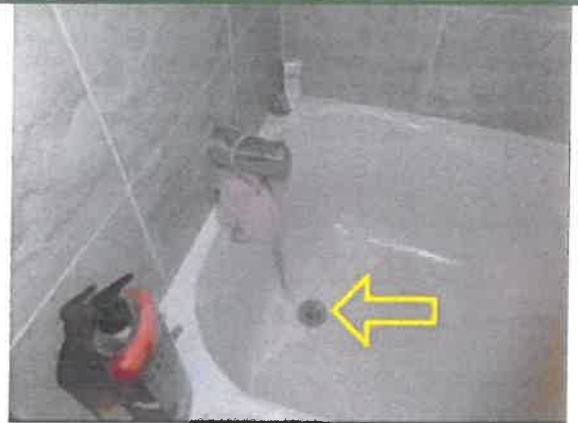
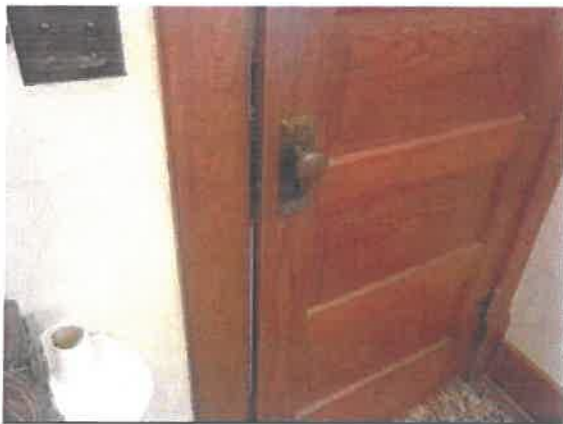
The drain stopper assembly on the tub was missing/broken. Repair as desired.  
Entry door does not latch and seal. Recommend adjustments to allow door to close as designed.  
Stains were observed on the ceiling and tested as having elevated levels of moisture. The bathroom exhaust vent is venting into the attic with the exit directly above this area that is testing as having moisture. Bathroom vent also addressed in the attic ventilation section.  
Recommend further evaluation/repair by qualified contractor(s).

door does not latch

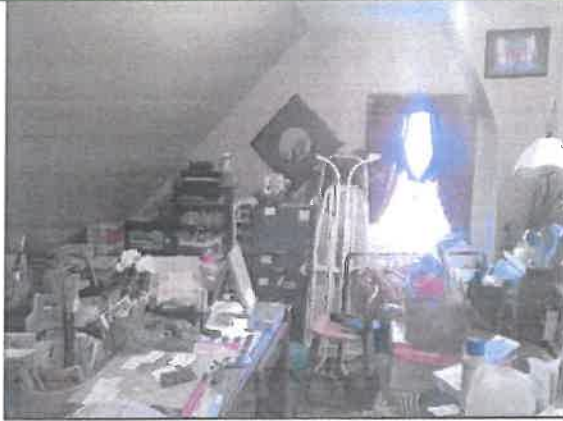
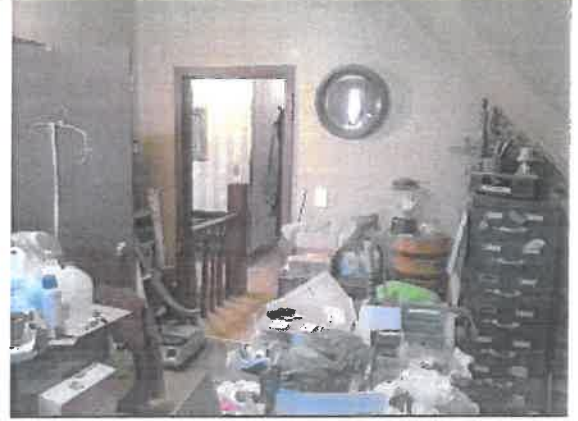
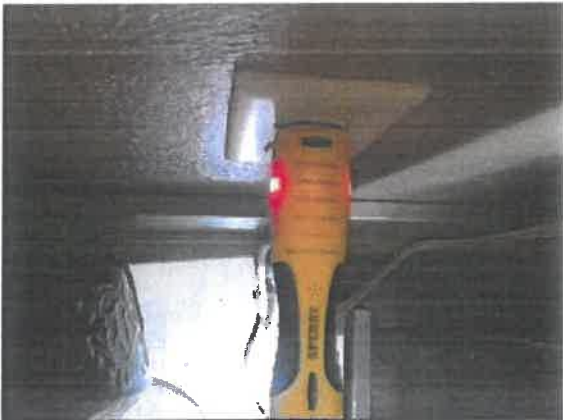
3-prong ungrounded outlets.

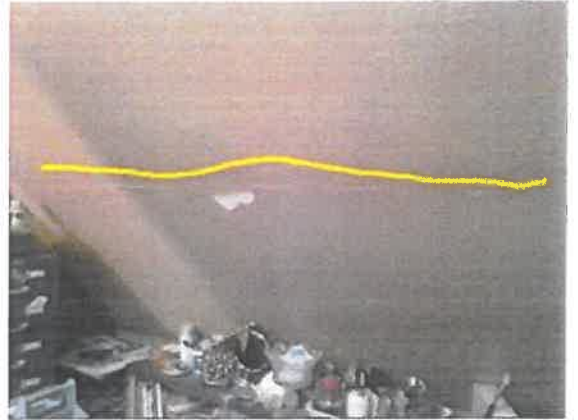
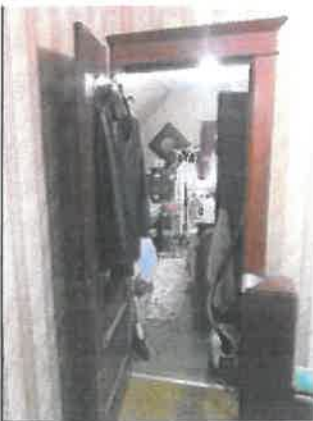
door opens into hallway

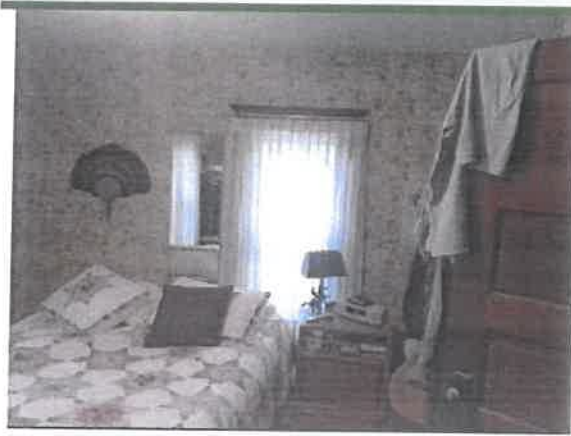
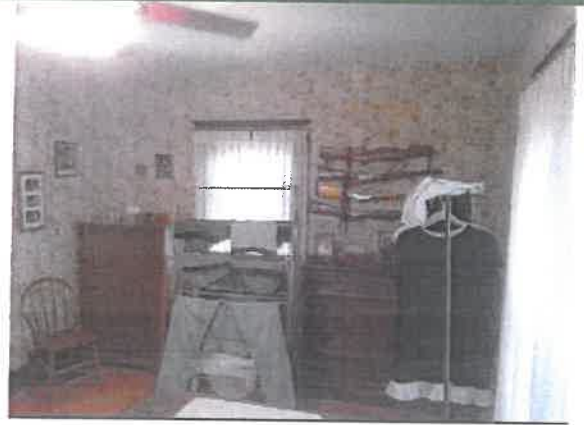
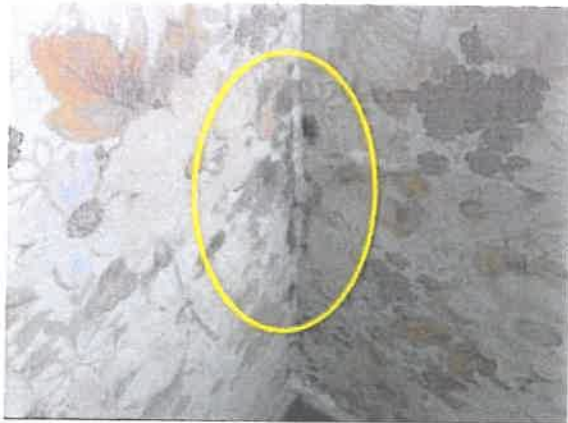
Stain(s) at ceiling tested dry on day of observation. Monitor for moisture related deterioration.  
 "Mold like growth" observed in the NW corner at time of this inspection. Mold identification and testing are beyond the scope of this inspection. Further evaluation/environmental testing should be considered to properly identify further environmental concerns and issues. Corner tested dry on day of inspection.  
 Outlets are 2 prong ungrounded outlets. This is common in homes built before 1962. Recommend further evaluation by a licensed electrician to see what steps can be taken to make the ungrounded outlets safer. Minimal outlets present. Refrain from overloading or use of extension cords as permanent power supply.  
 Limited access and views due to personal belongings.

organic growth

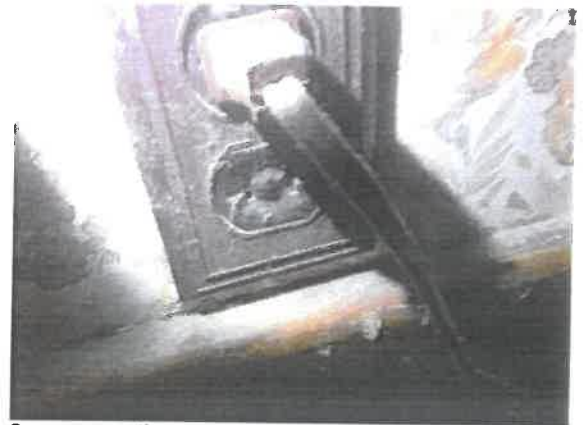
2-prong outlets

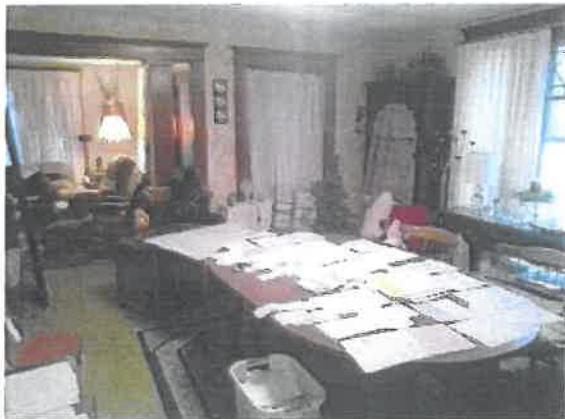
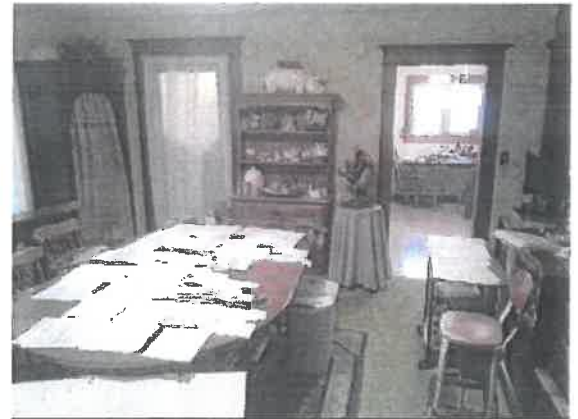
Minimal outlets present. Refrain from overloading or use of extension cords as permanent power supply.

Limited access and views due to personal belongings.

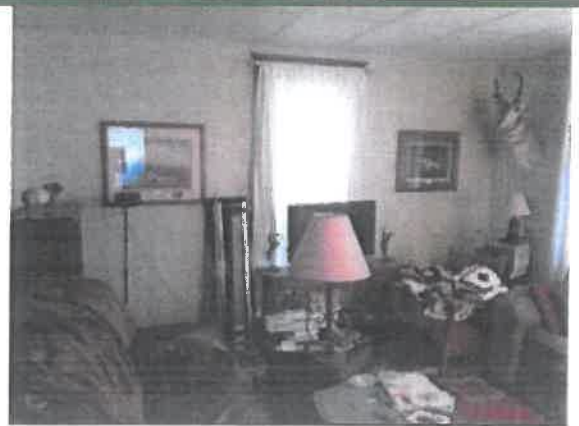
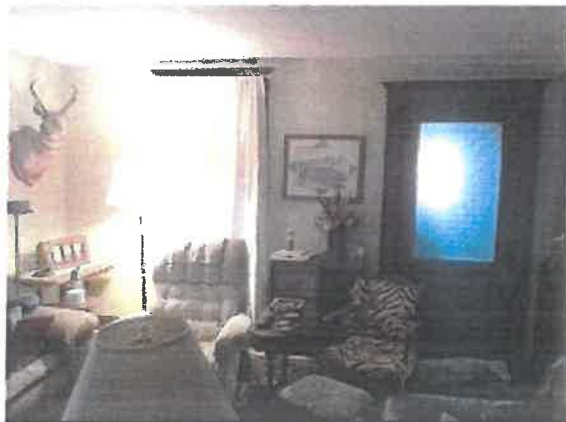
missing screens

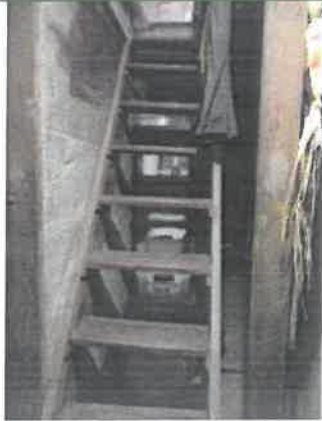
Steps leading upstairs were missing a handrail. Any stairway with four or more risers should have a handrail on at least one side.  
 Steps leading to basement have over spaced risers, and no handrail and an open wall. Stairs that have an open wall on one side should have a railing with balusters no more than 4" apart for safety.  
 Recommend further evaluation/repair by qualified contractor(s).

dangerous steps

Recommend Repairs

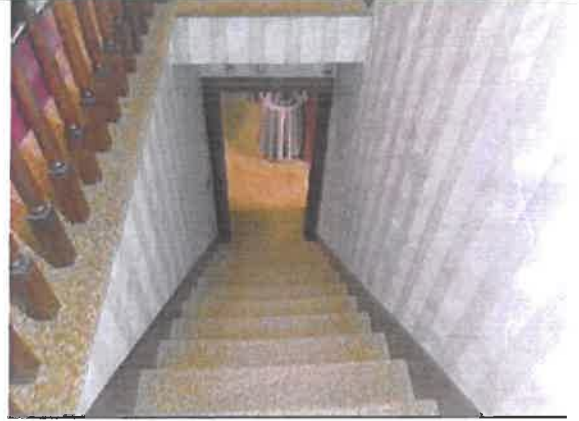
Missing Hand Rail

no handrail

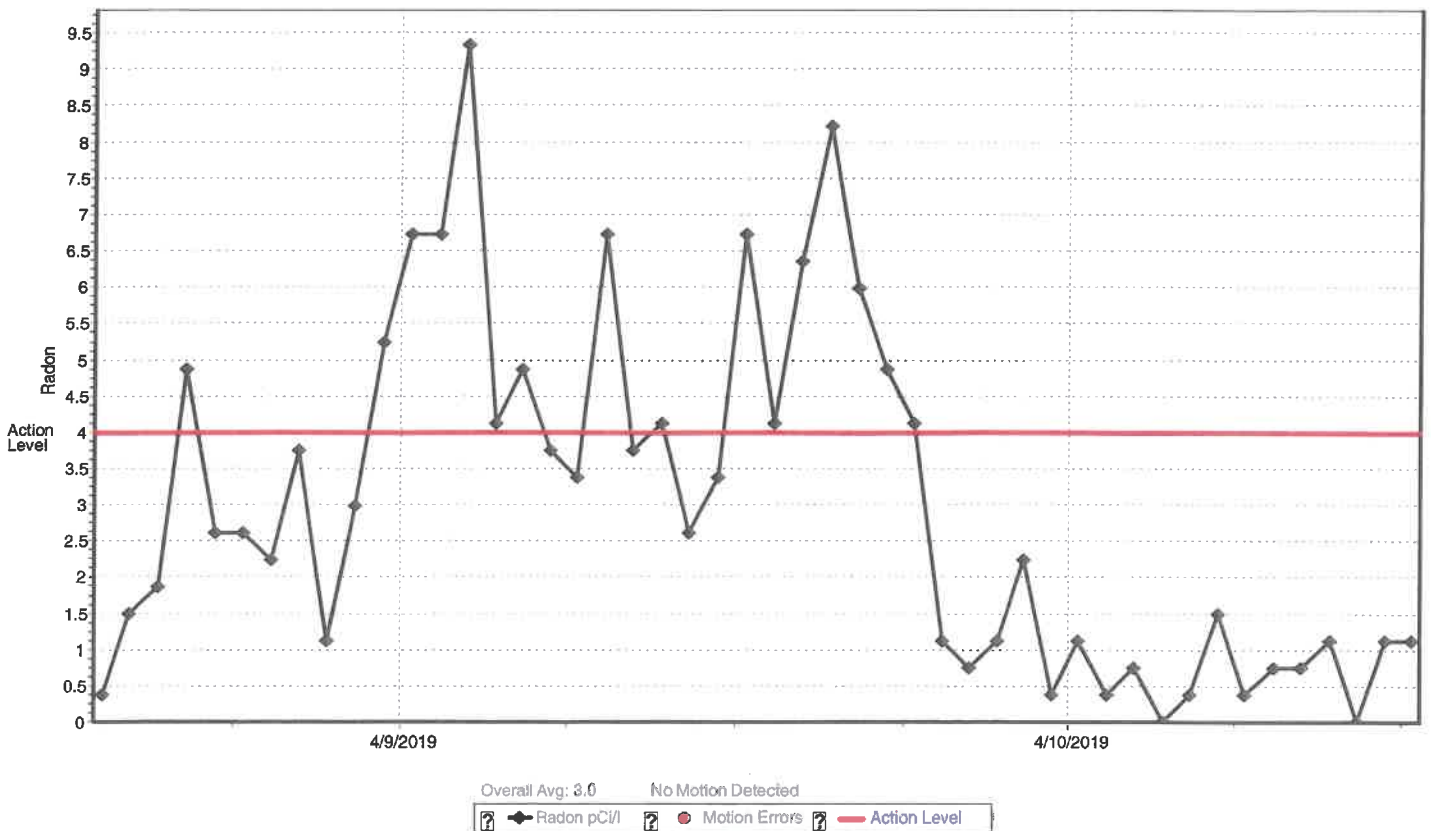
Atmospheric Condition: Recent Rainfall  
Structure Type: 2 Story  
Monitor Location: Basement

Overall Avg: 3.0 pCi/l  
EPA Avg: 3.1 pCi/l
